**An Independent Review of Incident #6053780
257 Elm Street, Atlanta, Georgia
Occurring
Thursday, November 23, 2006**

**Atlanta Fire-Rescue Department
675 Ponce de Leon Avenue, Northeast
Atlanta, Georgia 30308-1807**

January, 2008

Developed by an independent review committee consisting of Georgia Fire Service professionals

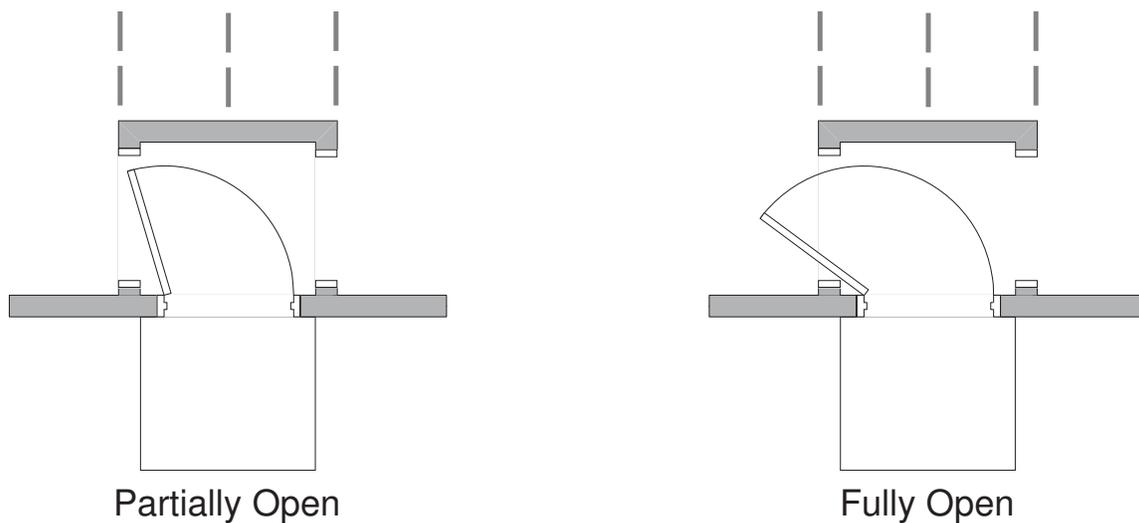
The front door swung inside and to the left and would become stuck in a position that blocked access to the left side of the house. E-16 OIC and E-16 FF1 reported that the smoke was so thick that they could not see the door or the vestibule wall as they entered. They ran into the wall straight ahead and felt the door to their left, leaving the opening to the right as the only available path to advance inside. (See Figure 3 showing partially open door.)

On initial opening, the front door would stop in a position that blocked access into the A/B corner room, leaving only a few inches of clearance from the back wall. The door would swing fully open if it was pushed with moderate force, allowing access to the A/B corner room. Individuals who entered after the flameover noted that the door had been pushed fully open. The door could have been pushed open by Firefighter Solomon as he either crawled or stumbled into the A/B corner room. (see figure 3)

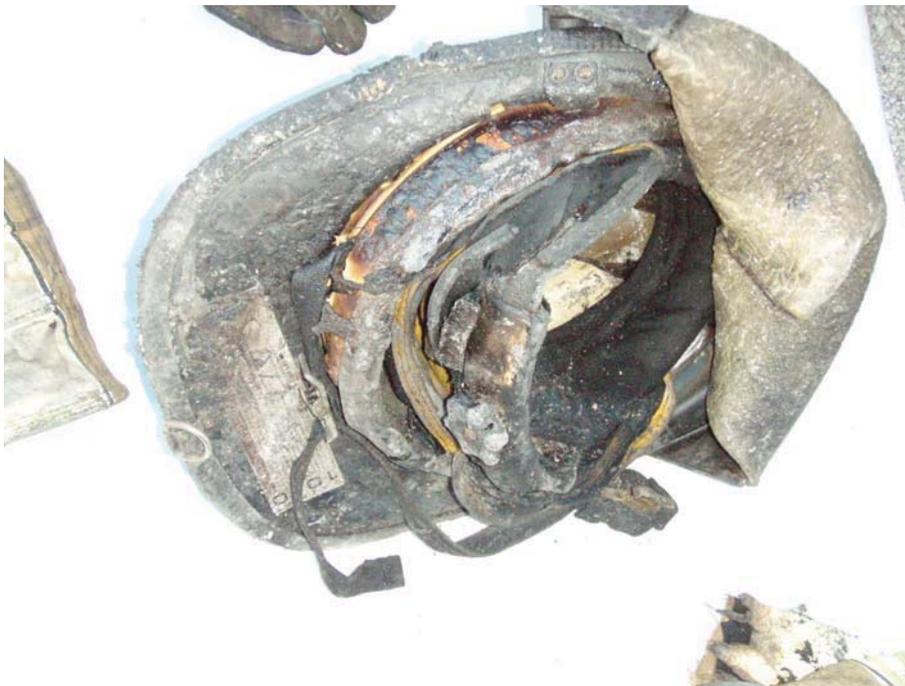
FF Solomon's Helmet: After reviewing the damage to the coat, pants, and hood of FF Solomon, attention was also given to his helmet found inside the structure approximately 10-12 feet away from the location from where he was extricated. We were unable to determine the sequence of events that led to his helmet removal and exactly when it was removed. It appears the helmet was removed early in the flameover event. While moderate heat damage appears to the outer shell, evidence indicates that severe damage to the underside of the helmet where the face shield melted in towards the inner shell possibly occurred on the floor and was not indicative of being on his head. On one side of the helmet, the buckle was melted; therefore it is difficult to determine if the strap was in place. If the helmet had been properly secured by the strap under the chin, then it would seem likely that if it had been knocked off, then it would stand to reason that it would have been caught by the regulator. Because it was found on the floor away from FF Solomon with significant damage to the underside, it is the panel's opinion that it was not secured properly. (See other photos in Appendix G).

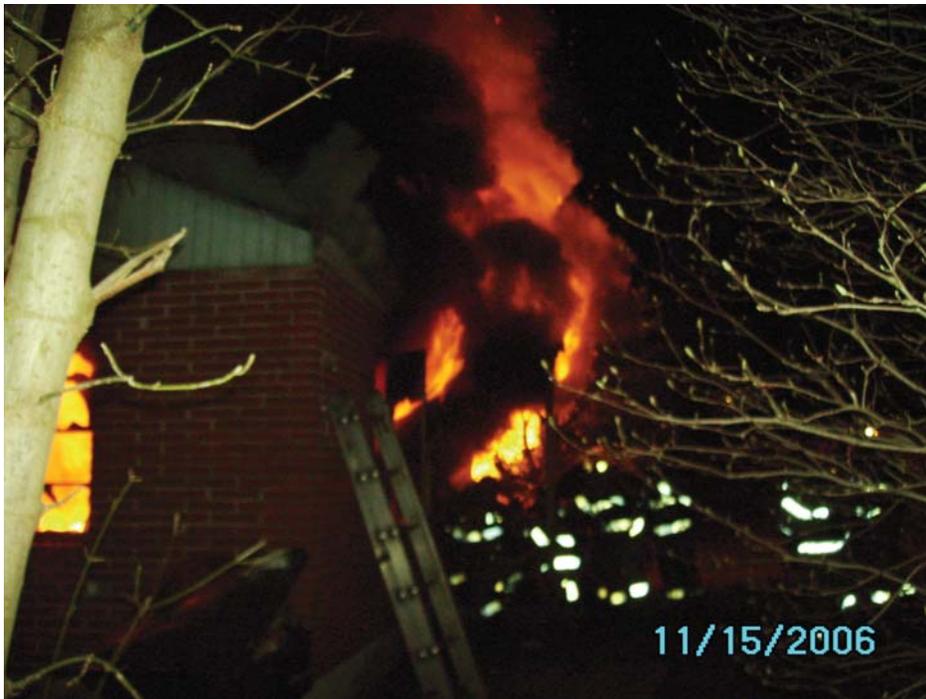
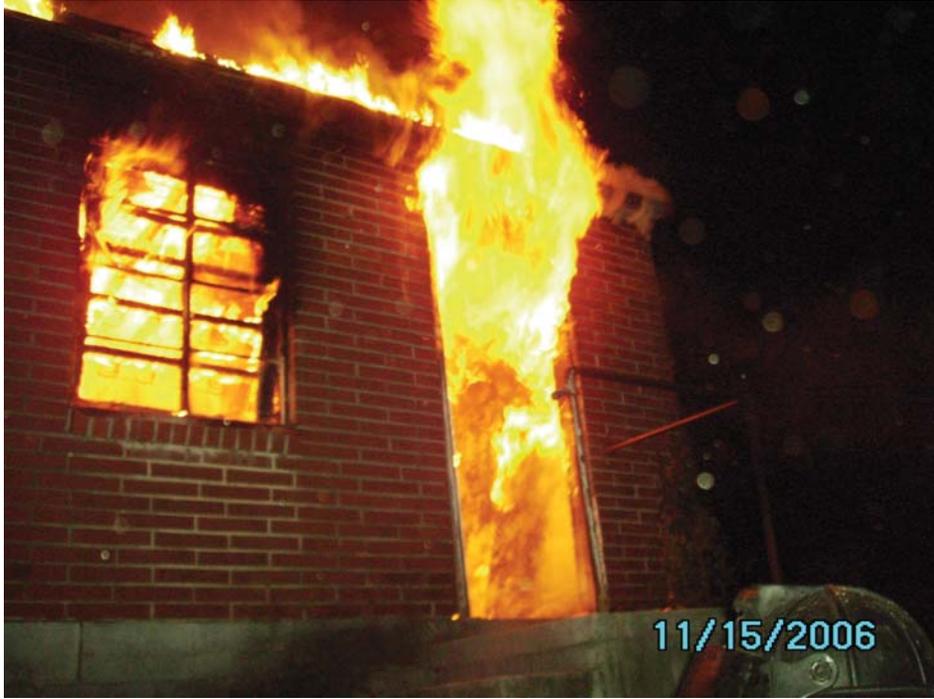
Squad Photos: These are a remarkable set of photos taken by the driver of Squad 4 which depicts the heavy fire conditions just after the flame over event occurred.

Note the quantity of firefighters at the front door. At least 7 individuals in PPE are visible. It is not clear if the OIC & firefighters are in this group or in the process of exiting.

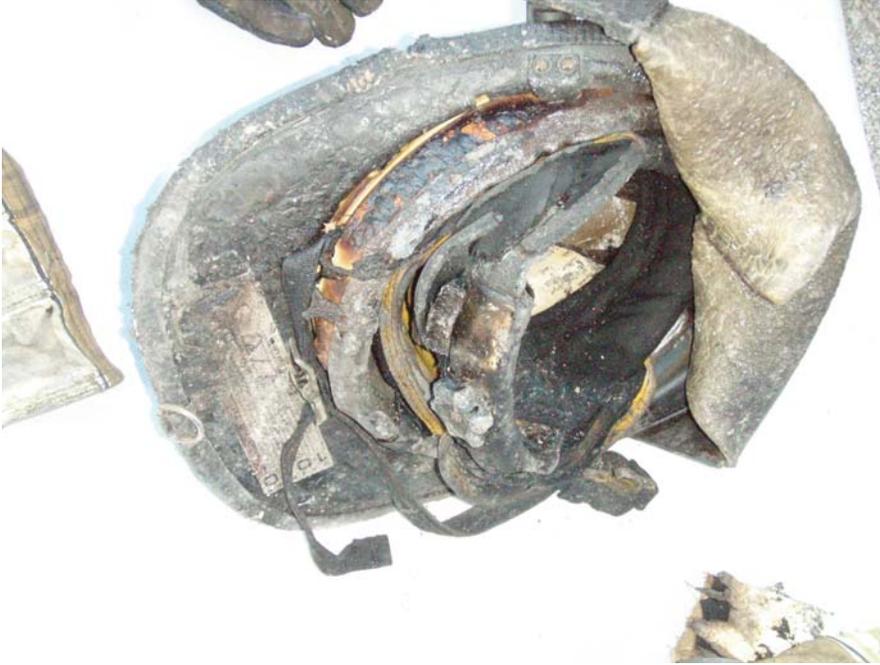
Underside of Firefighter Solomon's Helmet. Damage can be seen on the eye shield, the underside of the brim, and the suspension.

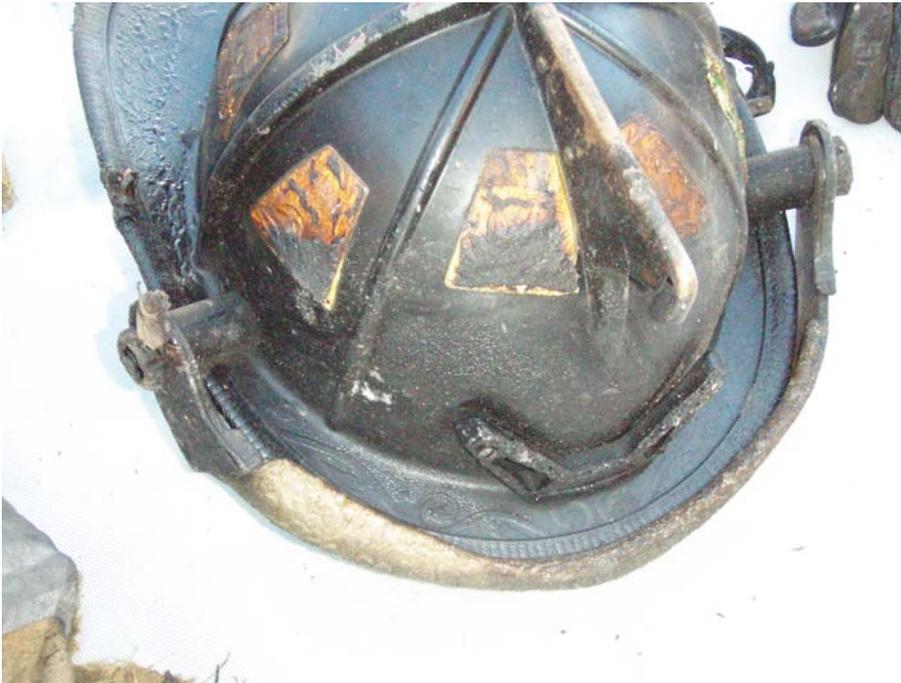
Top side and crown of Firefighter Solomon's helmet. Lack of damage to the crown and reflective trapezoids indicate the thermal damage to the helmet may have occurred with the helmet laying upside down on the floor.

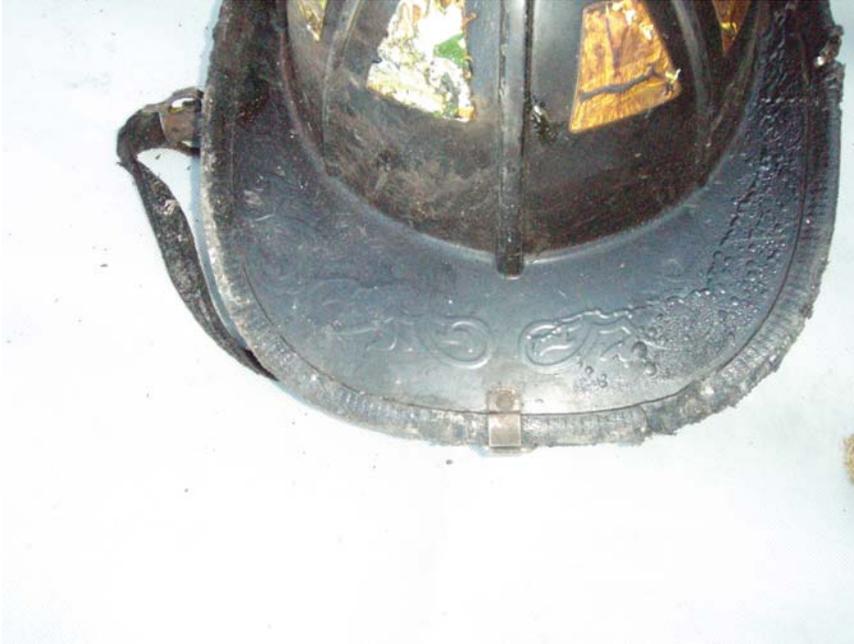
Rear brim of Firefighter Solomon's helmet. Note the relative lack of damage to rear brim.

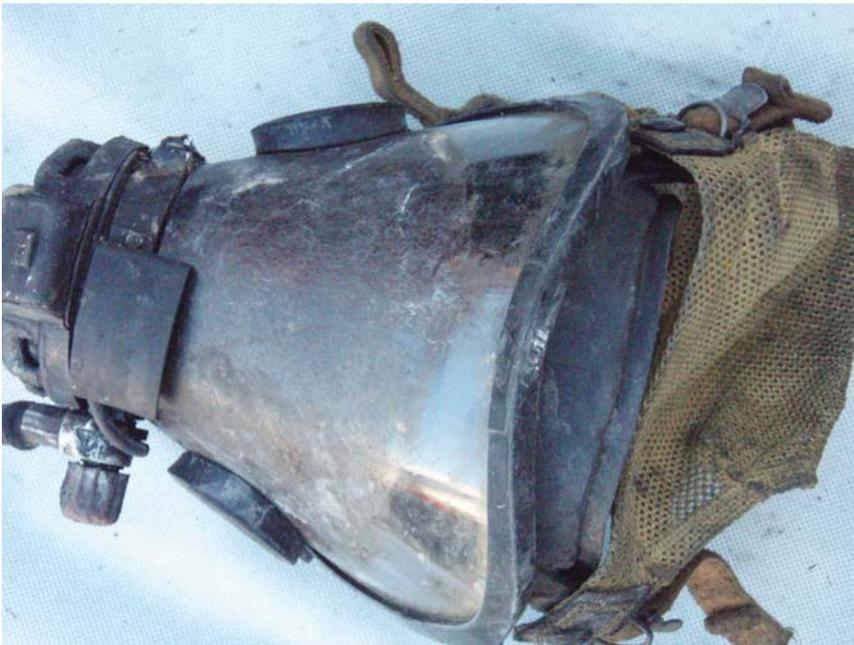
Initial examination of the self-contained breathing apparatus face piece indicates that the lens was intact, although most of the lens area had become opaque as a result of heat and flame exposure. The upper part of the lens appears to have been protected, most likely by Firefighter Solomon's protective hood. The condition of the lens suggests that Firefighter Solomon's vision through the face piece was compromised at some point while he was in the fire environment. This could explain why he removed his helmet, hood and face piece, which were all found along his assumed path of travel.

Firefighter Solomon's SCBA facepiece. Note crazing of the lens at the lower part of the face piece but relatively undamaged at the top. This could be due to coverage by Firefighter Solomon's hood. Also note the absence of damage to the harness This may also indicate that he was wearing his facepiece when the flameover occurred.

- Research should be conducted to determine whether existing performance standards for SCBA face piece lenses provide sufficient protection when firefighters are exposed to flashover conditions. Premature failure of the lens could have fatal consequences. If vision through the lens is suddenly compromised, the user could become disoriented and unable to locate a safe exit. The NIOSH report on the SCBA and face-piece was not available for review by this committee at the time this document was submitted.

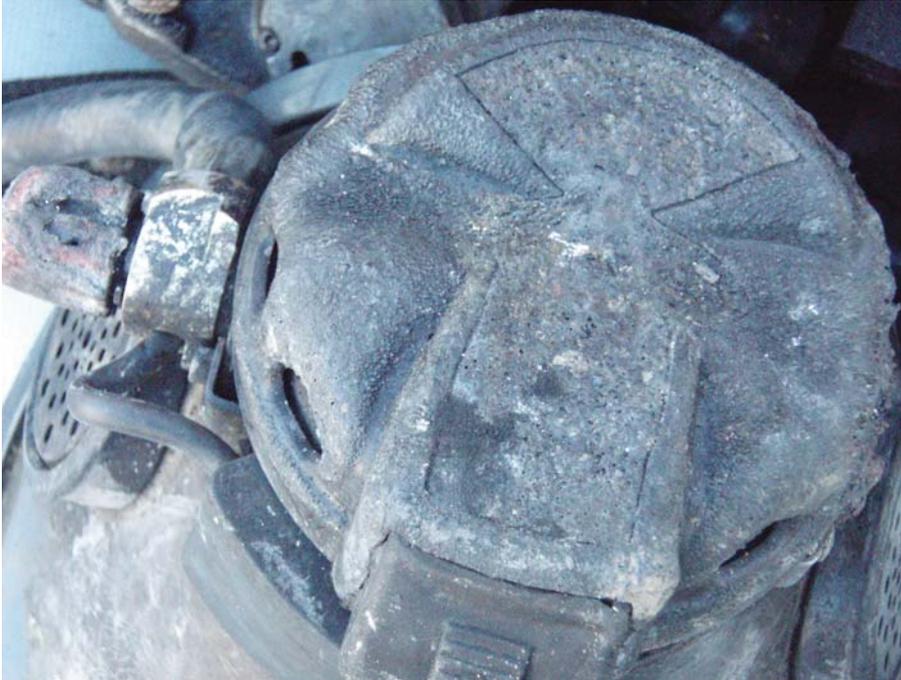
Thermal damage to outside of Firefighter Solomon's SCBA regulator.

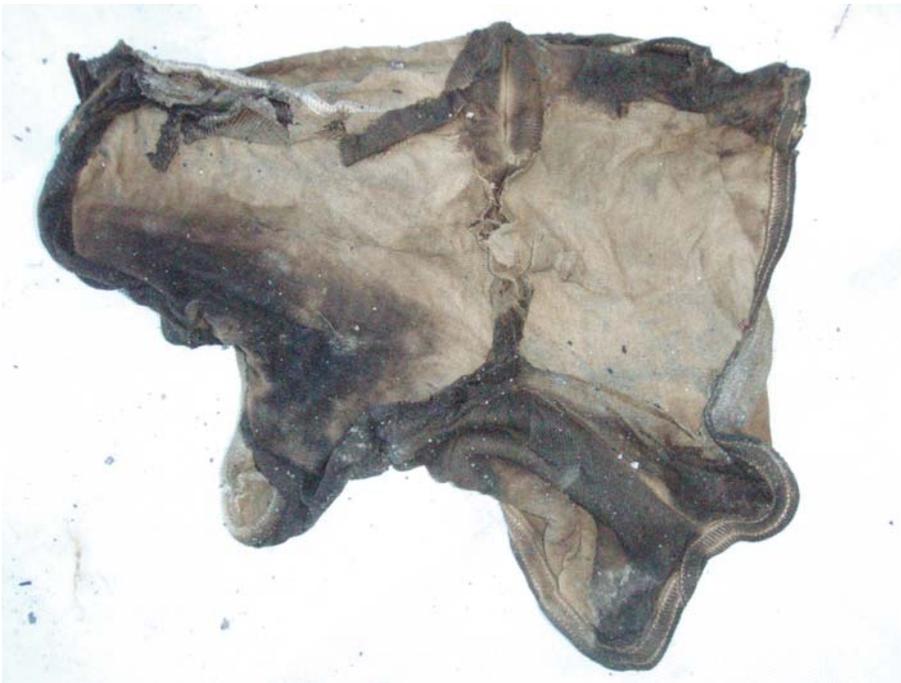
Firefighter Solomon's hood showing one layer of fabric burned away.

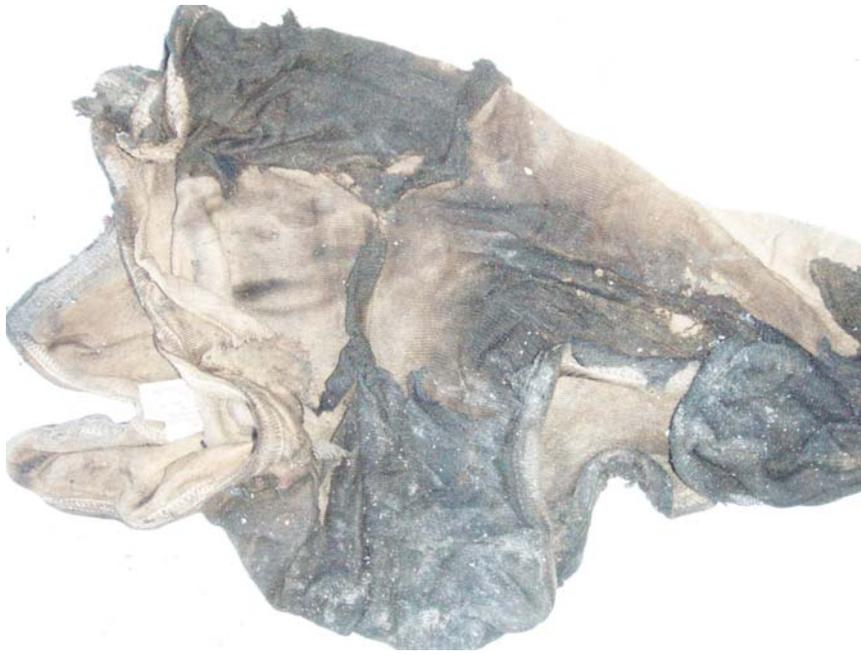
Thermal damage to Firefighter Solomon's hood/

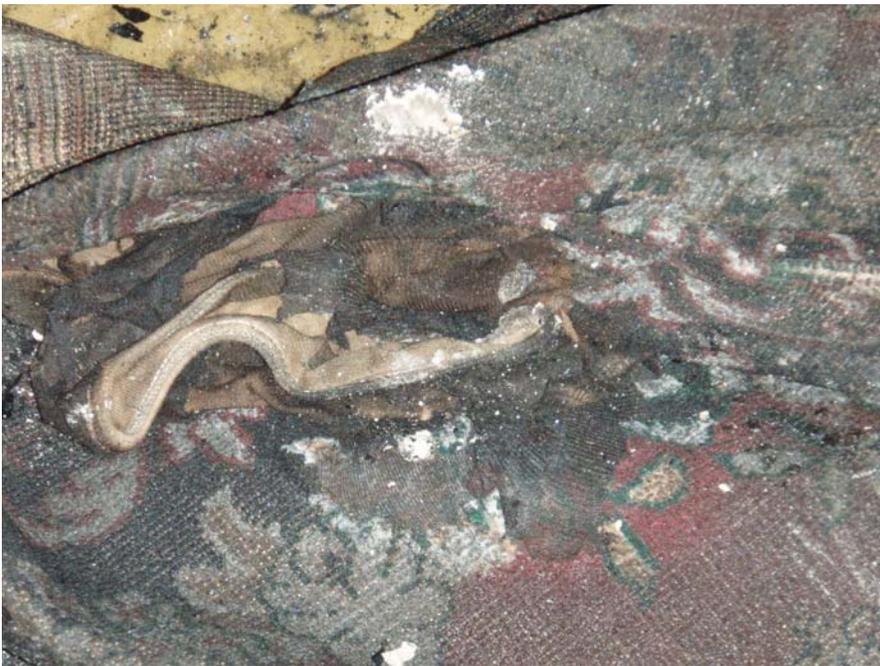
Firefighter Solomon's hood melted to a piece of a rug.

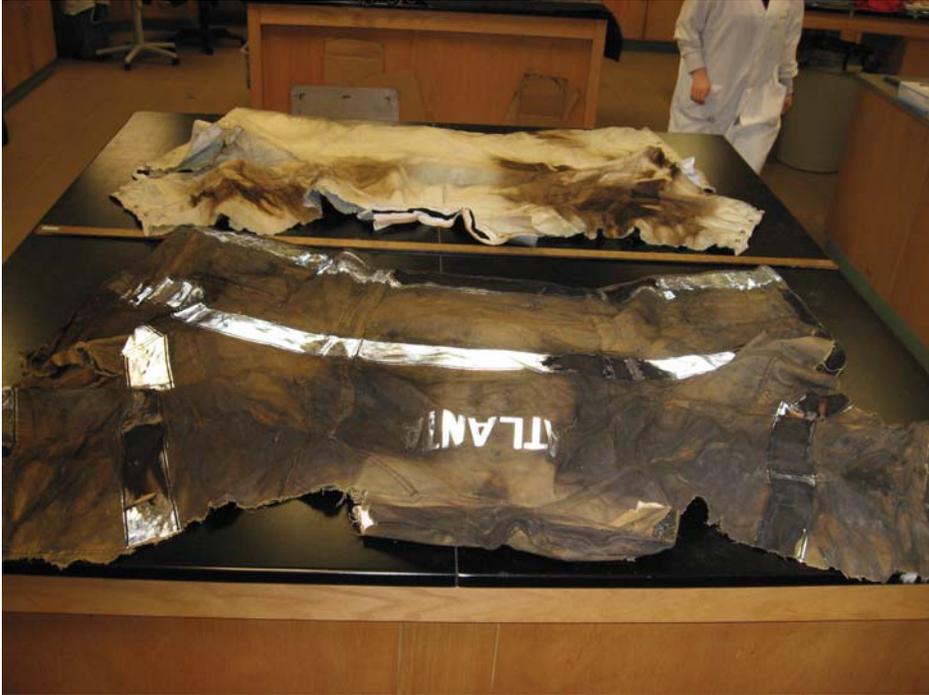
Firefighter Solomon's turnout coat and inner liner showing thermal damage.

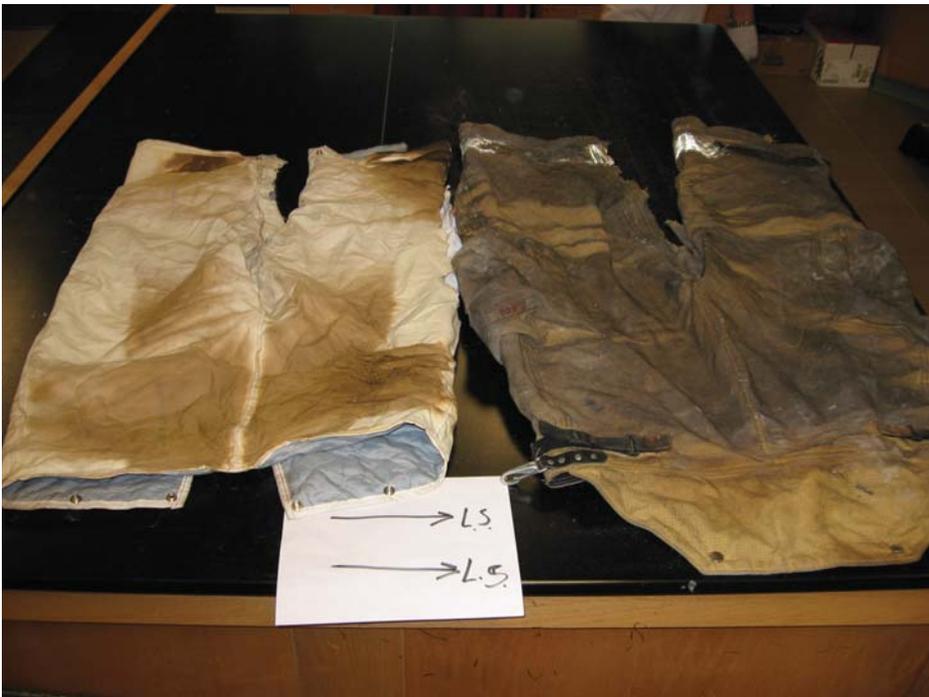
Firefighter Solomon's turnout pants and inner liner showing thermal damage.

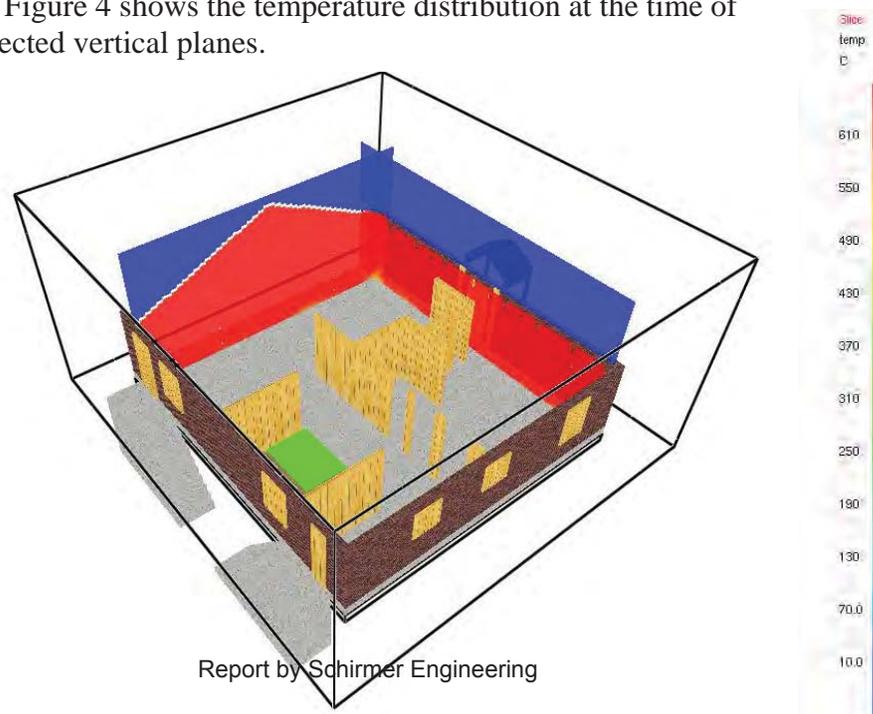
Figure 4: Temperature distribution at time of flameover. (Note: Temperature scale should be used as an approximation and not exact predicted temperature. For exact temperature predictions see appendix.)

As seen in Figure 4 above, once flameover was reached high temperatures were predicted at all elevations as well as the remote locations from the fire source. Two things can be concluded from this image. First, anyone within the compartment during flameover would experience the high temperatures, regardless of their location within the compartment. Second, Solomon would have experienced the same adverse conditions whether he was crawling or standing.
