**Cascade Toboggan Model 200 Advance Series Rescue Litter
Destructive Testing Results
June 27, 2000**

Cascade Toboggan Product Testing

Conducted at Rigging for Rescue in Invermere, BC Canada
June 27, 2000

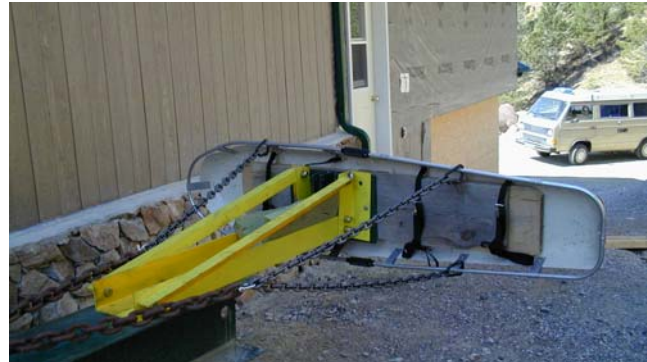
In this test the CTM200 was placed in a Slow Pull Device (SPD) whereby the ram of the SPD applied force directly to the bed of the litter at the point representing the litter's center of gravity under a specially made static harness constructed of heavy gauge chain and attached to the litter with steel carabiners. The distance from the top of the litter harness to the litter in the front was 74.5 inches; 77.5 inches in the rear.

A rigid backboard was manufactured to place in the bottom of the litter to distribute the load of the SPD across the length of the litter. The footprint of the backboard was 60 inches by 11.25 inches. The distance from the center of the ram to the end of the litter was 47.25 inches and from the head of the litter to the ram was 34.75 inches.

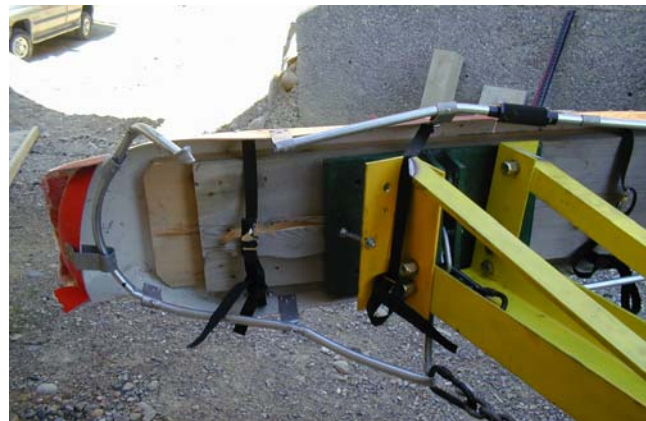
Force was applied gradually over a period of 32 seconds. Approximately 15 seconds into the test the litter sustained a downward load of 39.84kN. At this point the carabiner attached to right forward railing sheared through the railing. Force then dropped to approximately 22kN before climbing back to approximately 30kN when the left front railing sheared through

the bracket closest to the carabiner. At this point, the litter, while badly damaged was still attached to the litter harness by three of four attachment points. After several more seconds it was determined the litter had sustained enough damage to render it inoperable. Absolutely no damage was done to the ¹Fastlock™ System and the remnants of the litter were disassembled at the completion of the test.

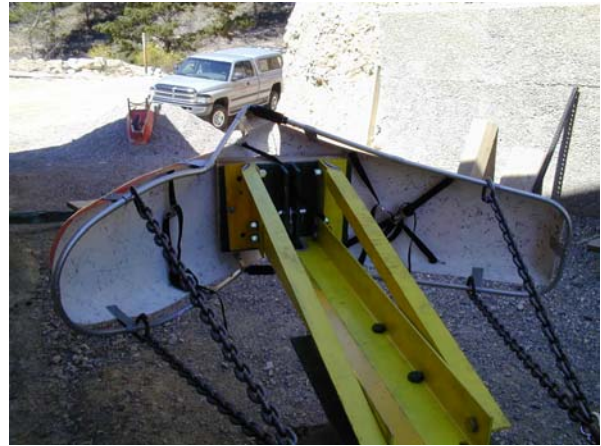
Test Two is identical in all respects to Test One with the exception that the footprint of where a load was applied was reduced to an 18 inch by 11.25 inch area directly over the center of gravity of the litter as it was attached to the static litter harness.

Force was applied gradually over a period of 40 seconds. Approximately 11 seconds into the test the litters sustained a downward load of 10kN. The litter then flexed and at approximately 28 seconds into the test failed at a sustained force of 10.06kN. The central point of failure occurred where the litter railing connected the ¹FastLock™ Coupler. The litter itself remained in one piece, but was considered to be inoperable.

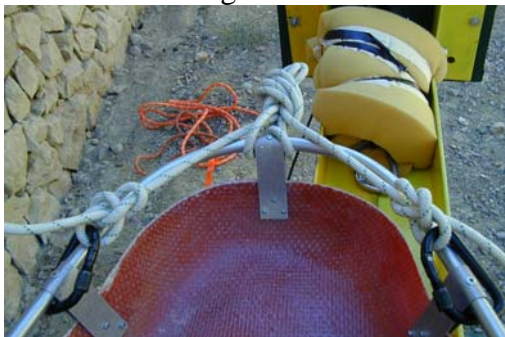
This test was designed to simulate the impact of load placed on the CTM200 if placed in an end to end “Inline” pull. The CTM200 was placed in the SPD and rigged with a 3 point inline litter harness as specified by the Technical Rescue Riggers Guide published by Rick Lipke. The litter harness was constructed of 11mm static Kernmantle rope.

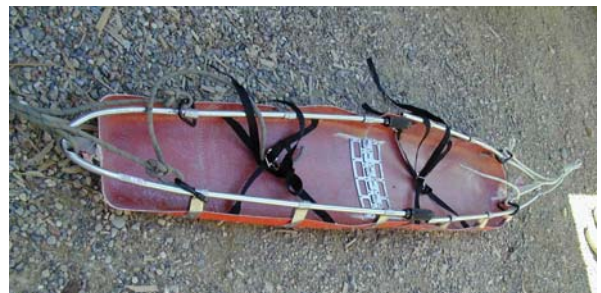
Force was applied gradually over a period of 28 seconds. At approximately 15 seconds force built up to 16.55kN. The first point of failure occurred where the nose railing bracket connected to the shell of the litter. The litter maintained structural integrity at a sustained force in excess of 15 kN until both the left and

right railing brackets at the nose were pulled from the shell and one end of the litter railing sheared from the FastLock™ System. It was observed that the litter was still in one piece and could be considered functional although patient integrity could have been compromised. It was also observed that the railing of the litter was the cause of central failure due to buckling.

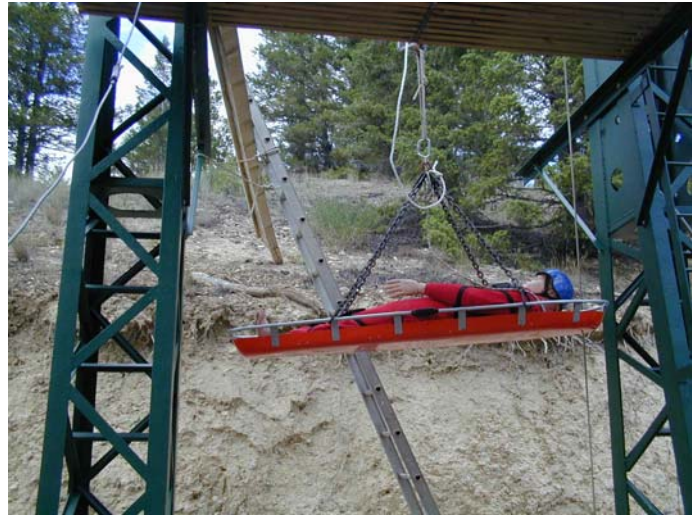
This test simulated a sudden, unexpected drop of the litter and the impact it could sustain from such a drop. The litter was rigged in a static litter bridle constructed of heavy gauge chain and attached to the litter with steel carabiners. The distance from the top of the litter harness to the litter in the front was 41 inches, 38 inches in the rear and 33.5 inches from the axis of the bridle to the railing of the litter at its center of gravity. The litter harness was then attached to three meters of 11mm static rope. The static rope was

folded and tied to contain one meter of slack that could be instantly loosed to simulate the drop. The CTM 200 as tested weighed 19 lbs and was loaded with a Rescue Randy weighing 173 pounds for a total weight of 197 pounds. The litter was hoisted up a drop tower for the test.

The CTM200 bounced slightly (approximately 3 inches) upon impact at the bottom of the rope. Impact was measured at 6.52kN. There was a very slight flex at the midpoint of the litter on impact. There was no damage to any part of the litter or railing.

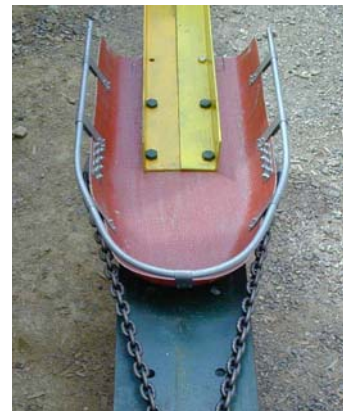
This test was conducted to determine the failure strength of the CTM200 configured with Vertical Pull Brackets used in a vertical raise or lower configuration. The nose end of the litter was used and was bolted to the SPD. A static bridle was attached to the Vertical Pull Brackets and attached to the SPD at a distance of 39.25 inches from the load. The width between the Vertical Pull Brackets was 20 inches.

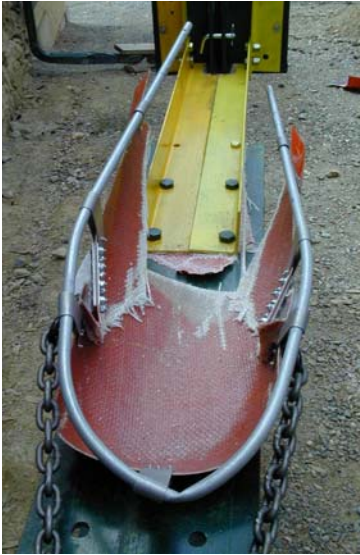
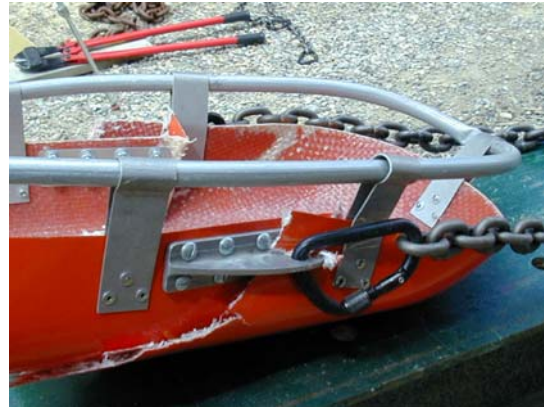
Force was applied over a period of 12 seconds. Peak force applied was 34.58kN at which time large sections of the litter shell cracked and allowed the Vertical Pull Brackets to move forward. As the Vertical Pull Brackets moved forward against the litter railing brackets, force was transferred to the litter railing ultimately causing it to buckle.
