**An Independent Review of Incident #6053780
257 Elm Street, Atlanta, Georgia
Occurring
Thursday, November 23, 2006**

**Atlanta Fire-Rescue Department
675 Ponce de Leon Avenue, Northeast
Atlanta, Georgia 30308-1807**

January, 2008

Developed by an independent review committee consisting of Georgia Fire Service professionals

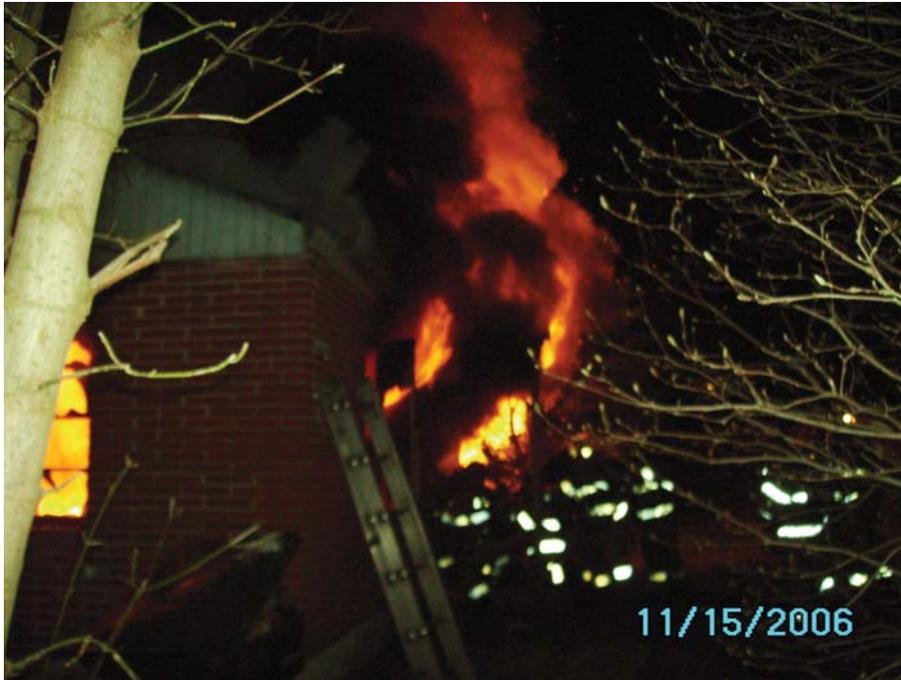
This photo shows the A / B corner. Note the number of firefighters at the front of the structure. This photo was taken as the flameover began.

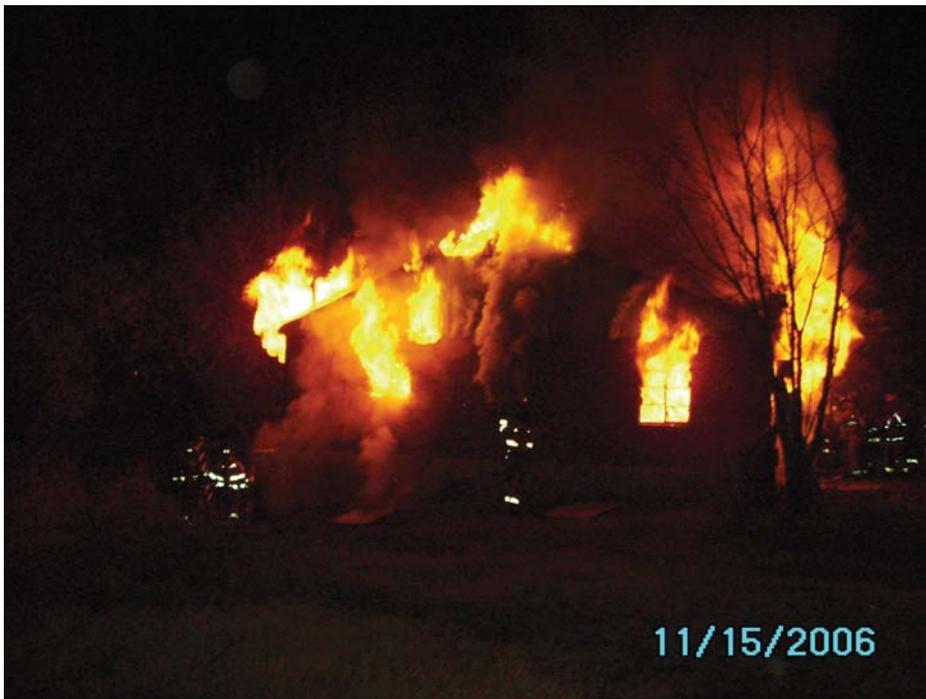
This photo shows the B side of the structure. Note the left window covering on the ground that is still smoking. The amount of firefighters at the front door has not significantly changed.

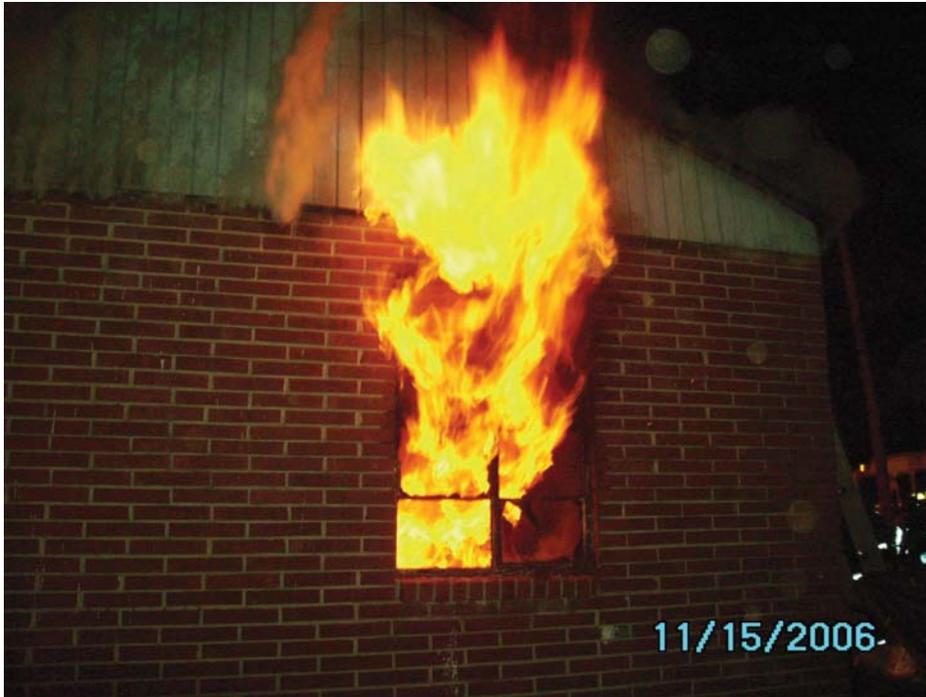
Fire issuing from the B / A corner of the structure.

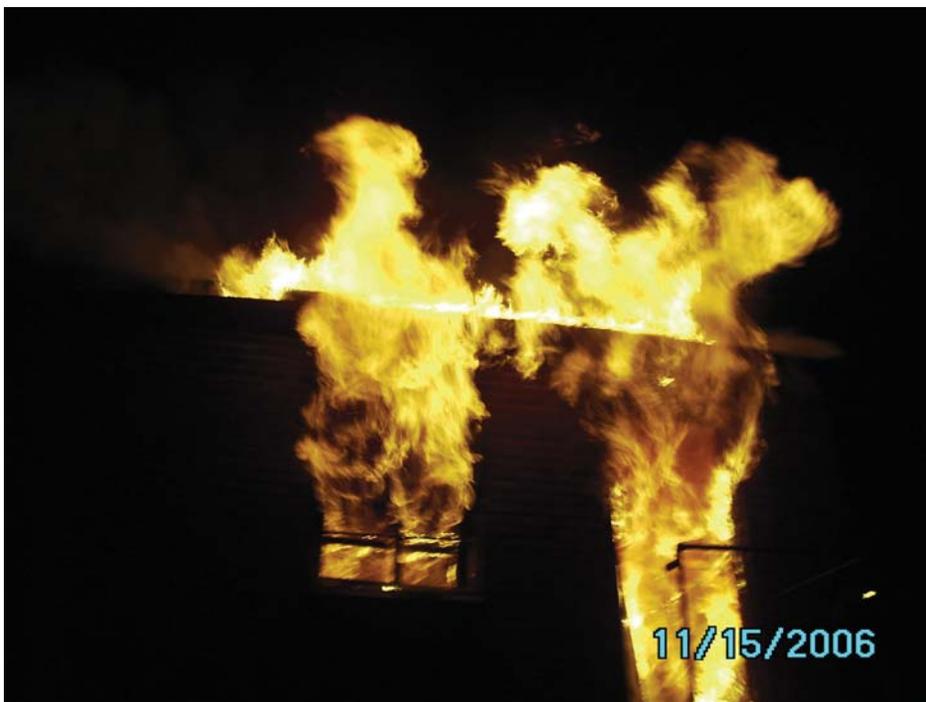
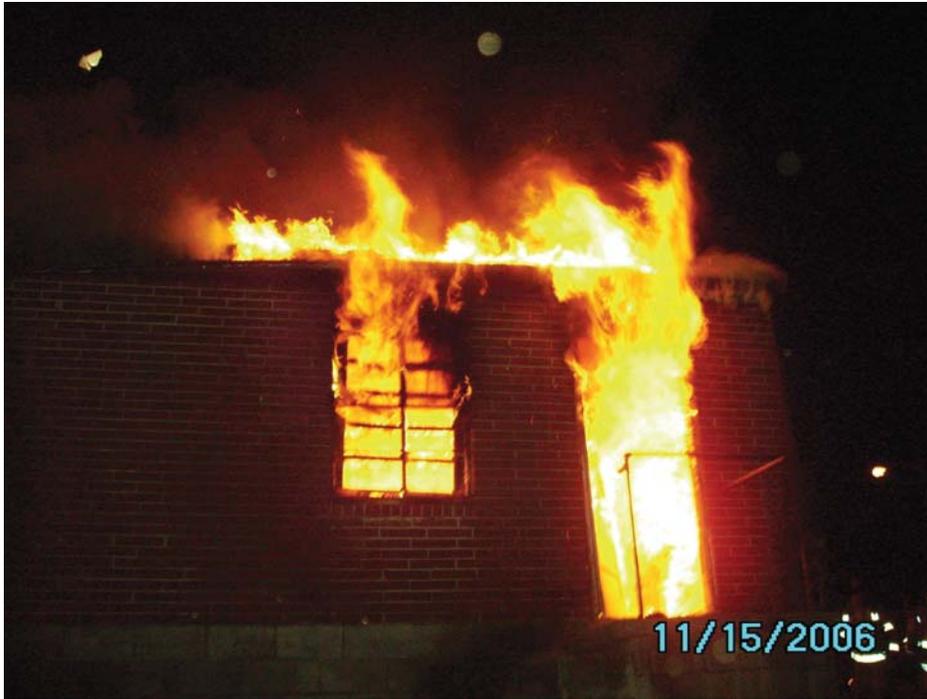
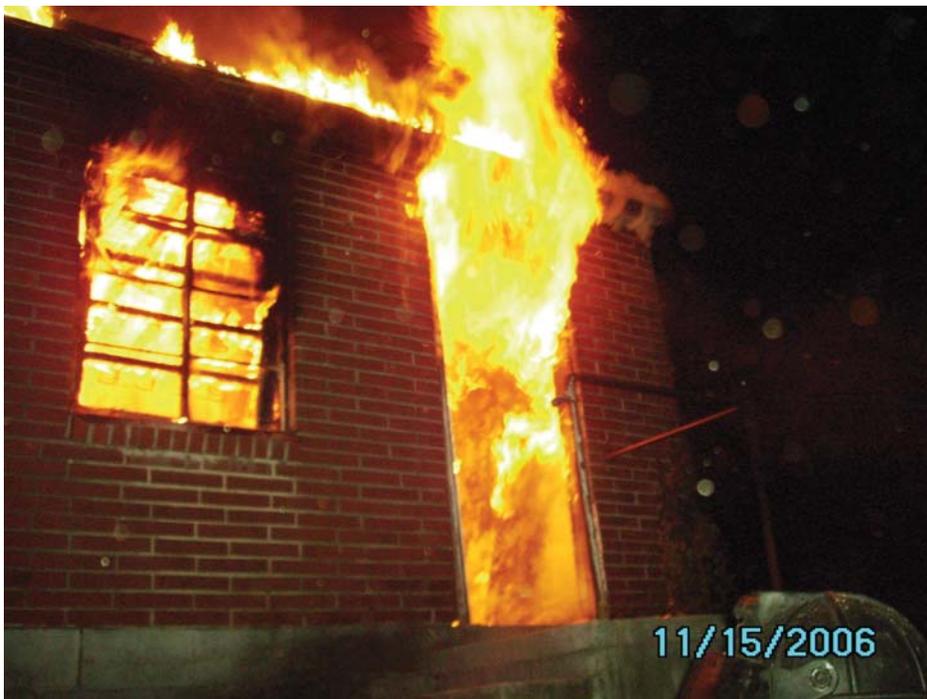
Fire issuing from the door and window of the room of origin on the C / B side of the structure.

Same as previous photo.

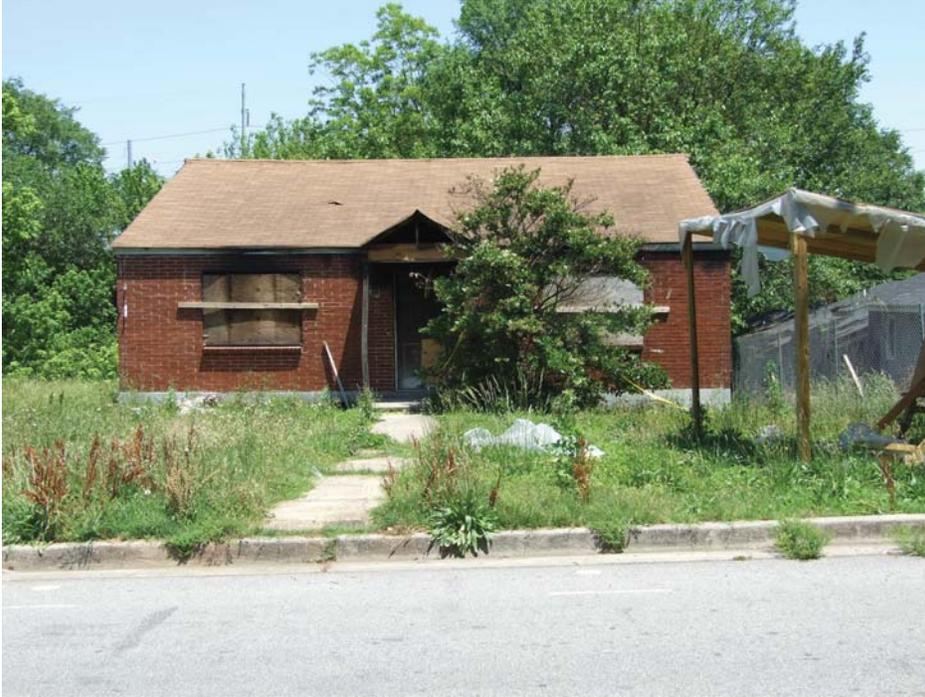
This is a photo of the A-Side of 257 Elm Street (post-incident).

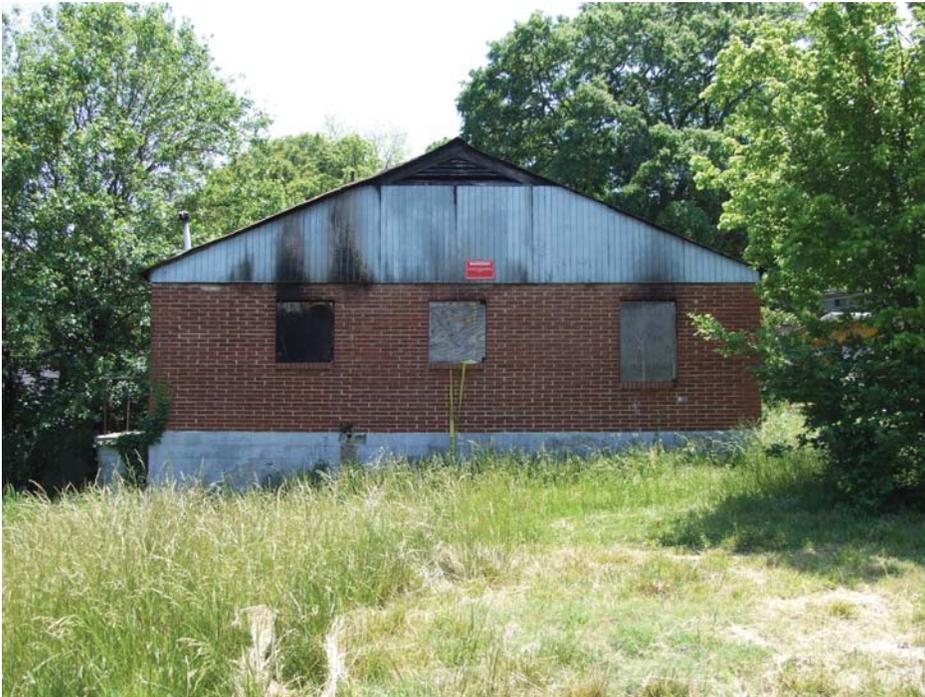
This is a photo of the B-Side of 257 Elm Street (post-incident).

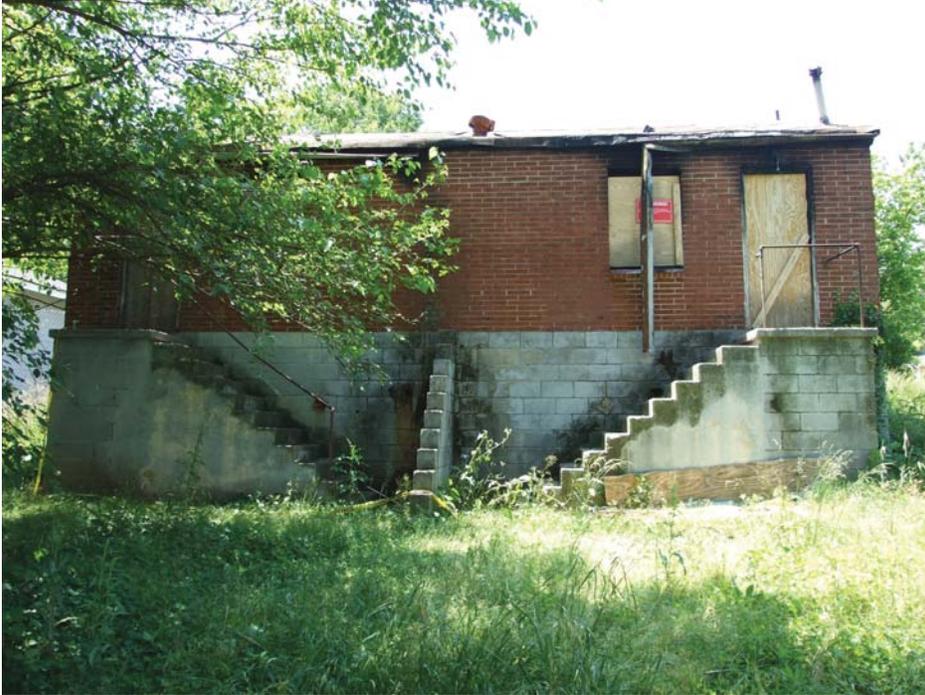
This is a photo of the C-Side of 257 Elm Street (post-incident).

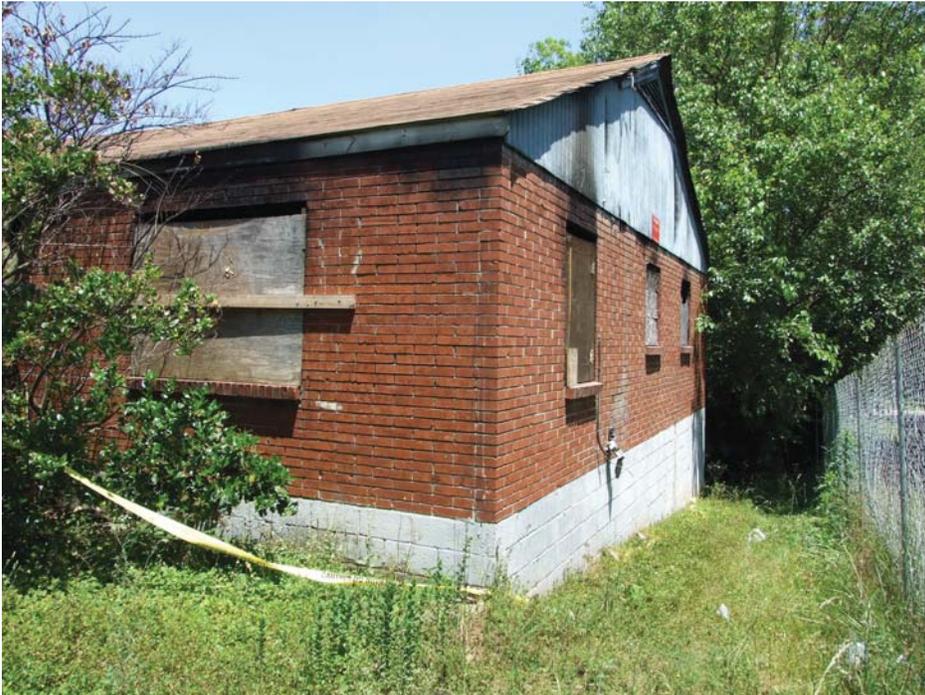
This is a photo of the A/D Side of 257 Elm Street (post-incident).
